TID and SEE Response of Advanced Samsung and Micron 4G NAND Flash Memories for the NASA MMS Mission

T. R. Oldham, M. R. Friendlich, A. B. Sanders, C. M. Seidleck, H. S. Kim, M. D. Berg,
and K. A. LaBel

Abstract— SEE and TID results are presented for two advanced commercial flash memories, Samsung and Micron 4Gb. Both have very good TID response, and very good SEU bit error rates, but the Samsung parts have lower SEFI rates and lower rates of destructive failures.

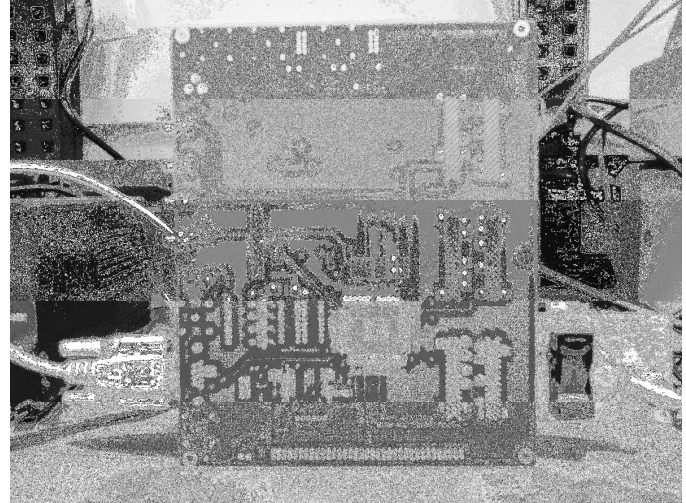
Fig. 1. LCDT Test System

Because Flash technology uses different voltages and circuitry depending on the operation being performed, testing was performed for a variety of test patterns and bias and operating conditions, using the NASA LCDT (low Cost Digital Tester), shown in Fig. 1.

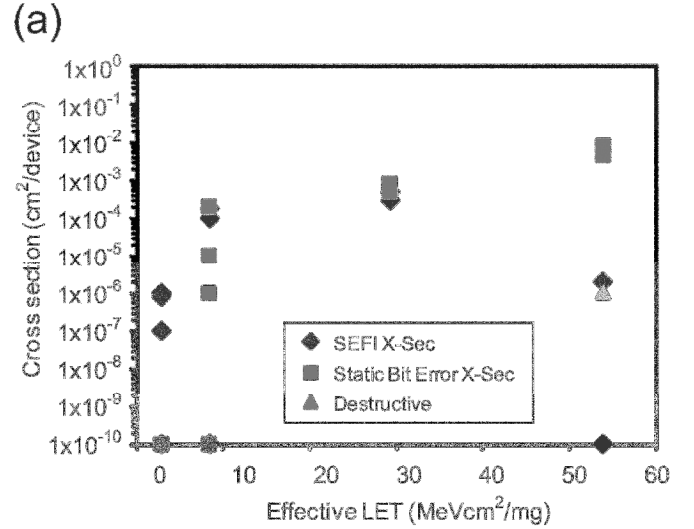
Fig. 3a. SEU, SEFI, and destructive failure results for Micron parts, in static mode with bias.

In the static mode with bias, for the Micron parts, there were 36 SEFIs due to block errors (where an entire block of 128Kx8 bits was lost, presumably due to a single ion), plus four other SEFIs, one of which was a destructive latchup (SEL). For the Samsung parts, there were a total of 27 shots, with 18 shots at oblique angles, with three SEFIs and no destructive failures. These results are summarized in Fig. 3.

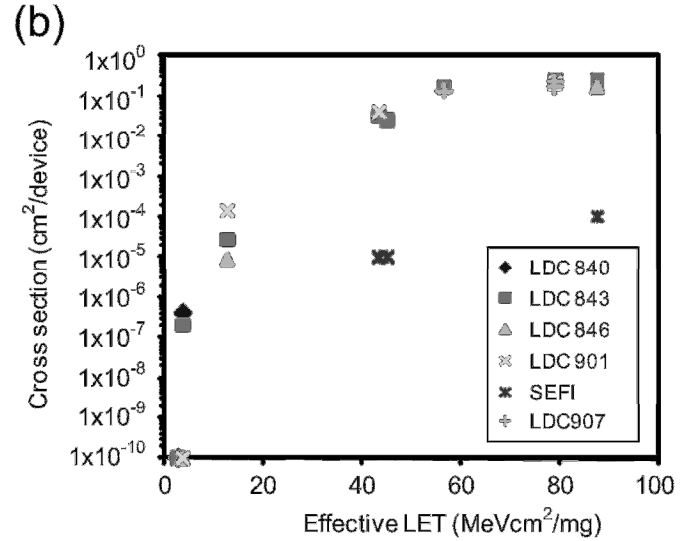
Fig 3b. Samsung results for SEU, SEFI, and destructive failures, in static mode with bias.

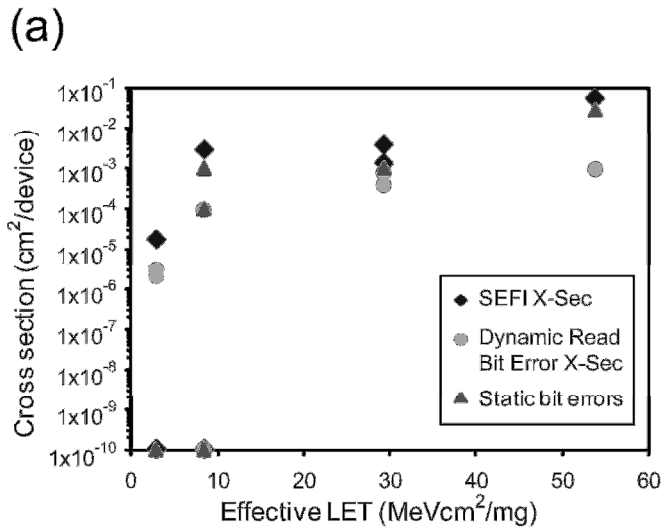
Fig. 4a. Micron dynamic read mode results for SEU, SEFI, and destructive failures.

For the Dynamic Read mode, results are shown in Fig. 4, for both manufacturers. Here, and also in the other dynamic test modes, transient errors are defined as those observed while the part is operating with the beam on. Static errors are the bits in error after the beam is turned off. For the Micron parts, there were a total of ten shots, with 36 block errors and two other SEFIs, with no destructive events. For the Samsung parts, there were 24 shots, including 17 at high angles, with two SEFIs and no destructive events.

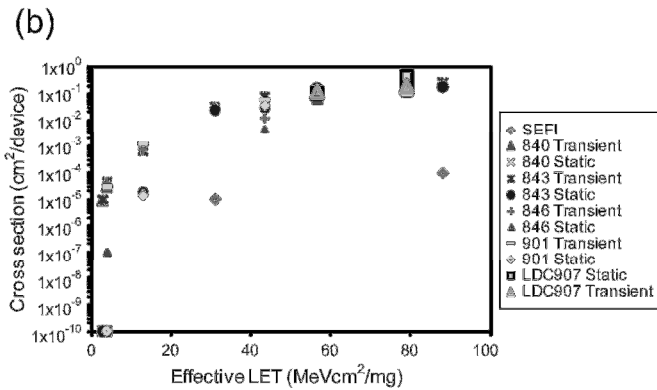
Fig 4b. Samsung dynamic read mode results for SEU, SEFI, and destructive failures.

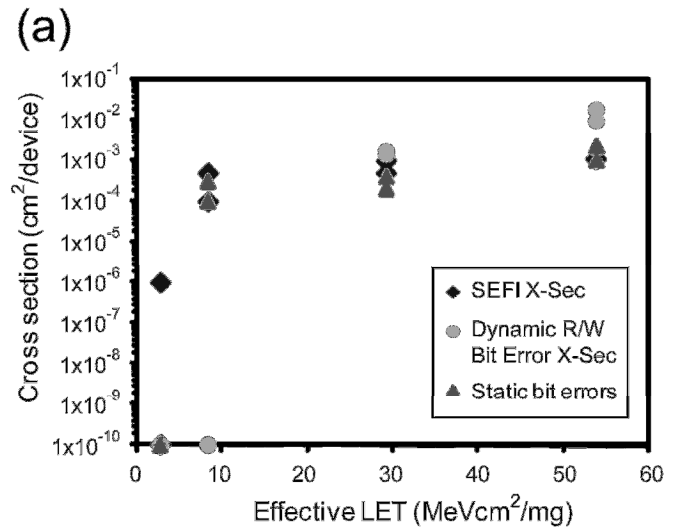
Fig 5a. Micron dynamic R/W mode results for SEU, SEFI, and destructive failures.

Results for the Dynamic R/W mode, for both manufacturers, are shown in Fig 5. For the Micron parts, there were ten shots in this test mode, there were 48 block errors and one other SEFI, and no destructive events. For the Samsung parts, there were 32 shots, including 24 at high angle, and nine at high temperature, with eight SEFIs and two destructive events. These were an erase failure with Au ions and a write failure with Xe ions.

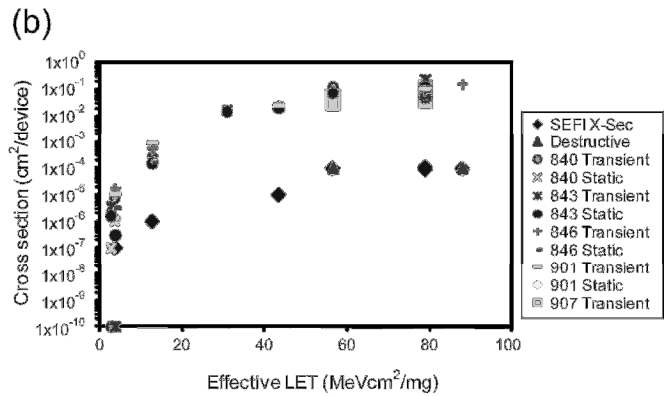
Fig 5b. Samsung dynamic R/W mode results for SEU, SEFI, and destructive failures.

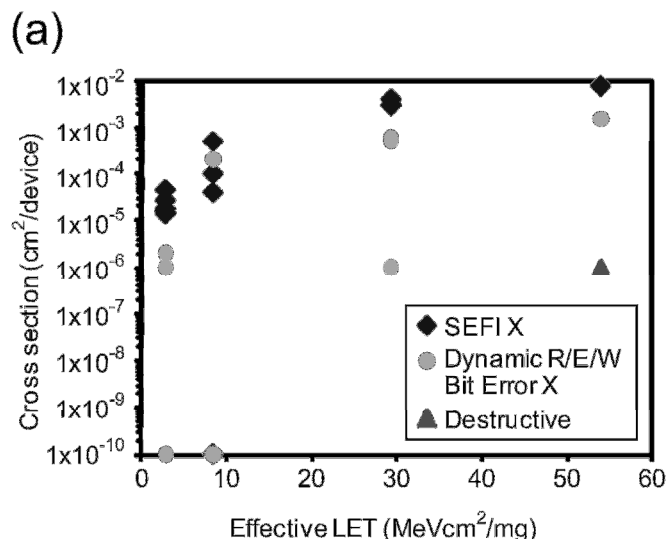
Fig 6a. Micron results in dynamic R/E/W mode for SEU, SEFI, and destructive failures.

Results for the Dynamic R/E/W test mode are shown in Fig. 6 for both manufacturers. In this mode, the high voltage erase and write operations are both being performed, so it was expected that this would be the worst case test condition for failures related to those operations. For the Micron parts, there were 15 shots, with 33 block errors and one other SEFI, plus one destructive latchup (SEL). For the Samsung parts, there were 77 shots in this mode, including 46 at high angle, and 54 at elevated temperature. In the first test trip, we found that the Samsung parts failed at high temperature (70° C) more often than at room temperature. Therefore, we made a second test trip to examine this temperature sensitivity in more detail. The Micron parts, on the other hand, failed at all temperatures, so we did not pay special attention to their high temperature response. The Samsung parts had 24 SEFIs and nine destructive events. These destructive events occurred only at normal incidence, even though most shots were at high angle. They occurred mostly (six of the nine events) at high temperature, and with high LET ions (eight of the nine with Xe or Au ions). The high temperature results for the Samsung parts for all the test modes are summarized in Table II.

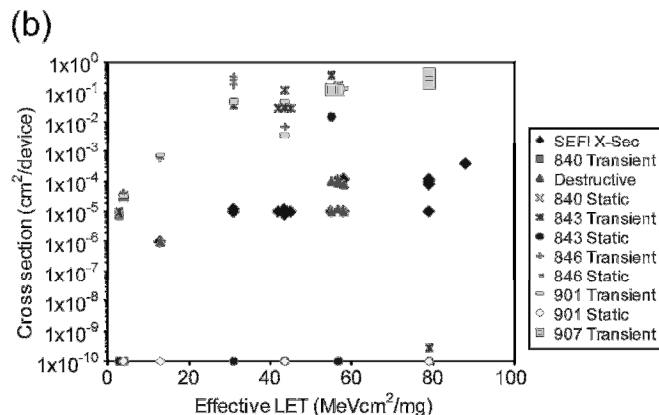
Fig 6b. Samsung results in dynamic R/E/W mode for SEU, SEFI, and destructive failure.

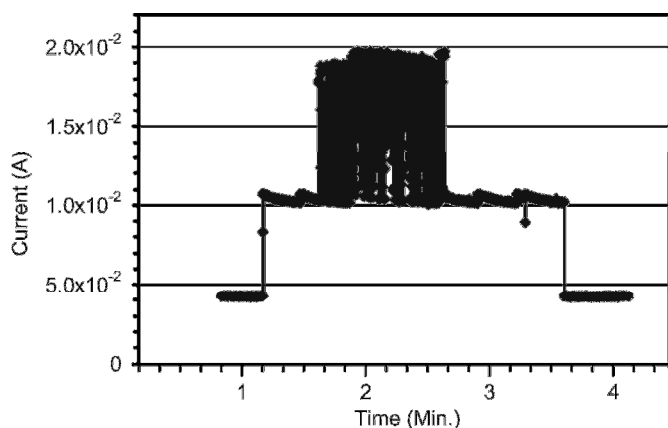
Fig. 7. Power supply current in R/E/W mode, Xe ions, at 25° C, with no permanent failure.

The power supply current was monitored on all shots, and representative sample traces are shown in Figs. 7-11. Typical power supply current traces are shown in Figs. 7 and 8 for two exposures using Xe ions in the R/E/W test mode. Fig 7 is at 25° C, and neither a permanent failure, nor a SEFI occurred. Fig. 8 is at 70° C, and both a SEFI and a permanent write

failure occurred. For these parts, normal read current is about 10-11 mA., and write current in a fresh part is about 15-17 mA, although it increases as a part degrades over multiple shots. Erase current is 8-9 mA, and the current is about 4 mA, when the part is idling, not doing anything. In Fig. 7, the sample starts to read, and then the beam is turned on, and write

pulses start, as errors are found. Write pulses continue after the beam is off, until all the errors are corrected, but the part continues to read after that, just to make sure. Finally, there is another read to verify the part is ready for the next shot. Fig. 8 shows the sample starting to read, then to have write pulses as errors begin to occur, but then the current increases to 20, 30, 40, 50 mA, and higher. When the beam is off, current stabilizes at about 57 mA. The write circuit had failed—the bit map showed the entire memory erased, because the erase circuit still worked, but none of the rewrite operations were successful. Fig. 9 shows the power supply current for a static (with bias) shot, where no SEFI occurred. The sample idles at 4 mA while the beam is on. After the beam is off, there is a read operation to count errors, and a second read to check for annealing, then an erase to prepare for the next shot, a read to verify the erase, a write to restore the test pattern and a final read to verify the write. Fig. 10 shows a similar power supply current trace, for a Dynamic read mode shot. The sample reads while the beam is on, then there is another read to count static errors after the beam is off, followed by an erase, a read to verify the erase, a write, and another read to verify the part is ready for the next shot. Fig. 11 shows results for a R/W mode shot. The sample writes while the beam is on, then reads static errors (twice), then erases, reads, writes, and reads again to verify the part is ready for the next shot. Note that in none of these current traces do we see the current spikes that have been reported elsewhere [1].

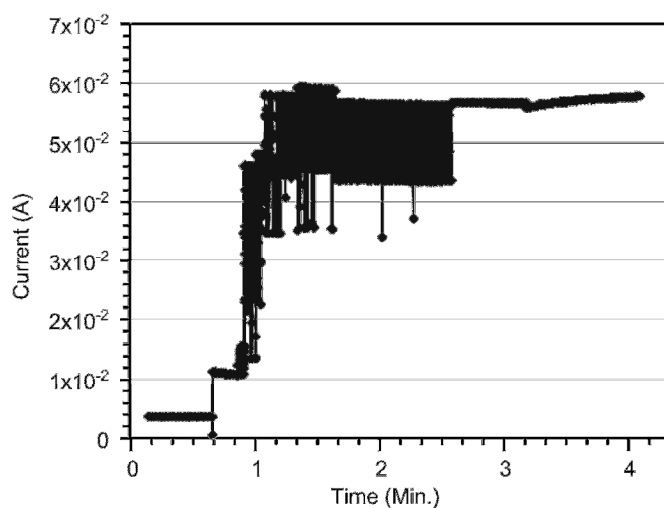
Fig. 8. Power supply current in R/E/W mode, Xe ions, at 70° C, with permanent write mode failure.

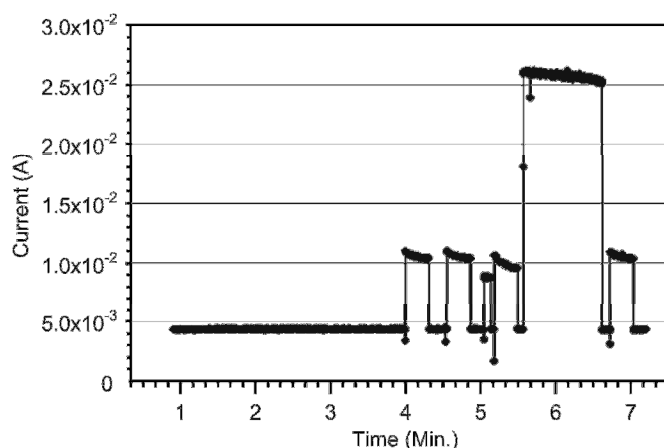
Fig. 9. Power supply current in Static mode, with bias, Ar ions, with no failure.

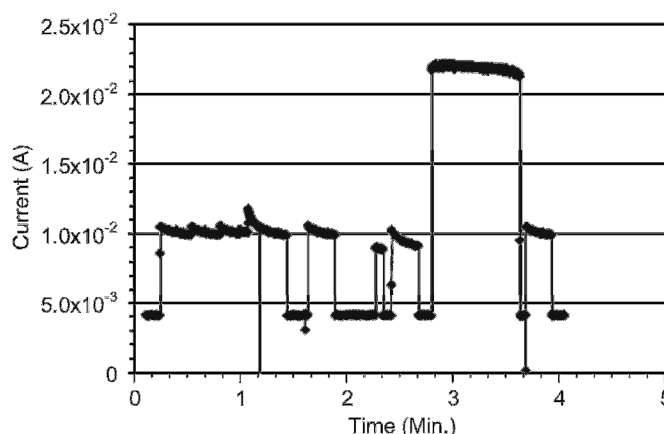
Fig. 10. Power supply current in Dynamic Read mode, Kr ions, with no failure.

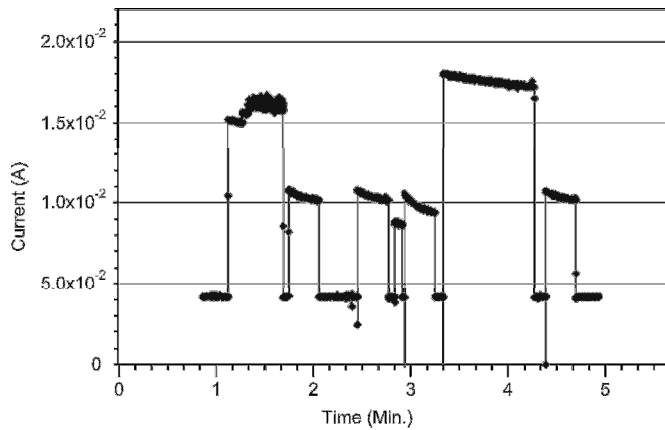
Fig. 11. Power supply current in R/W mode, Xe ions, with no failure.
